**REPORT NO. 04-17**

**SURE-LOK, STYLE II CONTAINER, 40" x 48",  
MIL-STD-1660 TESTS**

**VALIDATION ENGINEERING DIVISION  
MCALESTER, OKLAHOMA 74501-9053**

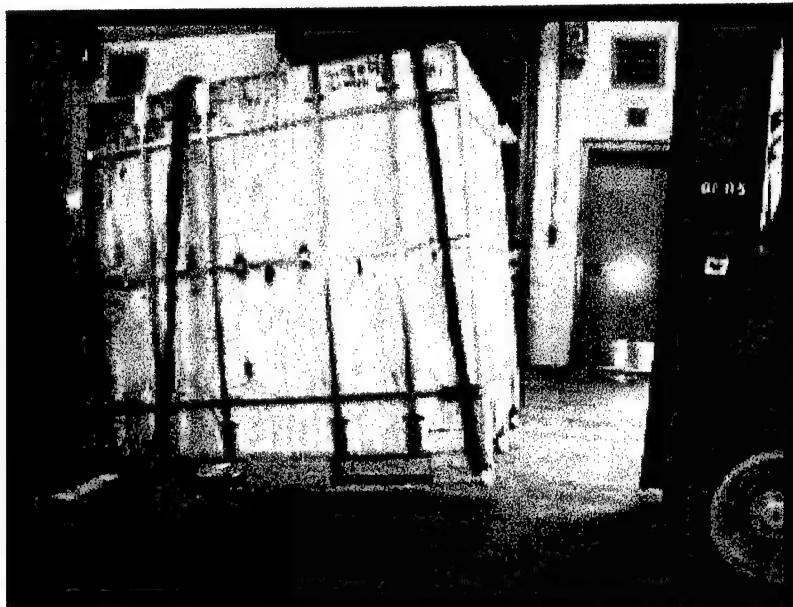
**Photo 8. Test Setup for Drop Testing.**

**3. EDGEWISE ROTATIONAL DROP TEST.** Test Unit #1 was edgewise rotationally dropped from a height of 12 inches on both longitudinal sides and both lateral sides. No damage was noted from this test. See Photo 8 for the test setup for the drop tests.

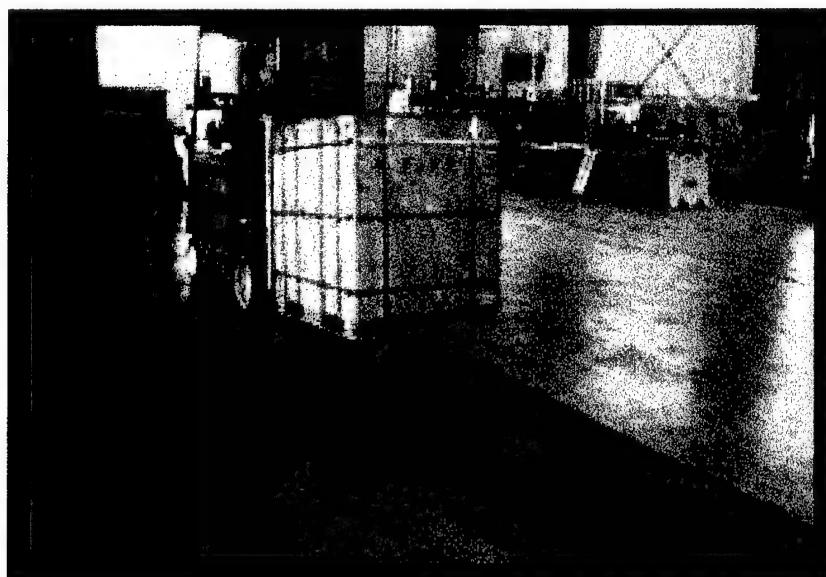
**Photo 10. Test Setup for Forklift Testing.**

**5. FORKLIFTING TEST.** Test Unit #1 was lifted from the end of the pallet on the forks of the forklift truck and carried over the hazard course three times with no damage or instability noted. The test unit was lifted from the opposite end of the pallet and the above steps accomplished with no problems encountered. See Photo 10 for the test setup during the forklifting test.
